HISTORIC RESOURCE INVENTORY FORM

Resource Address: 919 S Bench St Galena Illinois 61036 USA
County: Jo Daviess
Historic name: Garage
Present name: Garage
Local place name:
Visible from public right of way: Yes
Ownership:
Owner/Address:
Land unit size:
Site/Setting:

Project: Historic Resources of Galena, Illinois	Sequence/Key no.:	Survey Date:
Prepared By:	Report Title/Name:	Previous Surveys:
Inventoried: 12/09/2013 8:39:10 pm Last updated: 11/02/2019 1:27:51 am by /	Level of Survey: <input type="checkbox"/> Reconnaissance <input type="checkbox"/> Intensive	Additional Research Recommended? <input type="checkbox"/> Yes <input type="checkbox"/> No

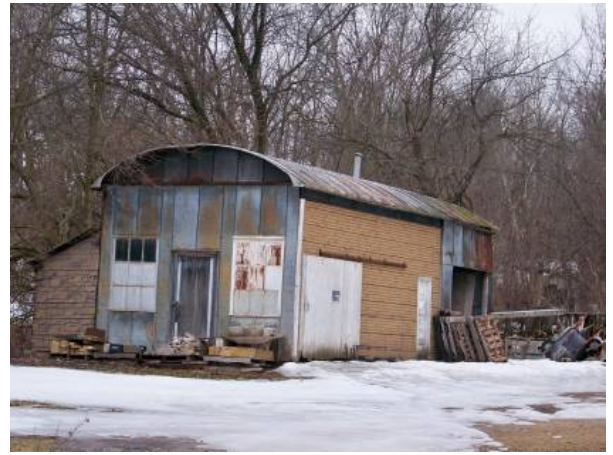
Category: building, domestic building	Style:	<input type="checkbox"/> Additions <input type="checkbox"/> Alterations <input type="checkbox"/> Moved <input type="checkbox"/> Other Ancillary structures:
Structural:	Exterior Material(s): brick	
Stories: 1, Bays:	Roof Material: Metal	
Form or Plan: , rectangular	Roof Type:	
Foundation: Concrete Block	Windows:	
General condition: Deteriorated	Chimney(s):	
Basement:	Porch:

This is a 1-story domestic building built ca. 1950. The building is rectangular in plan. The foundation is concrete block. Exterior walls are brick. Windows are original or historic wood fixed. Doors are contemporary aluminum glazed.
