HISTORIC RESOURCE INVENTORY FORM

Resource Address: 608 S High St Galena Illinois 61036 USA
County: Jo Daviess
Historic name: House
Present name: House
Local place name:
Visible from public right of way: Yes
Ownership:
Owner/Address:
Land unit size:
Site/Setting:

Survey and Recorder		
Project: Historic Resources of Galena, Illinois	Sequence/Key no.:	Survey Date:
Prepared By:	Report Title/Name:	Previous Surveys:
Inventoried: 12/10/2013 8:55:53 pm Last updated: 12/10/2013 8:55:53 pm by /	Level of Survey: <input type="checkbox"/> Reconnaissance <input type="checkbox"/> Intensive	Additional Research Recommended? <input type="checkbox"/> Yes <input type="checkbox"/> No

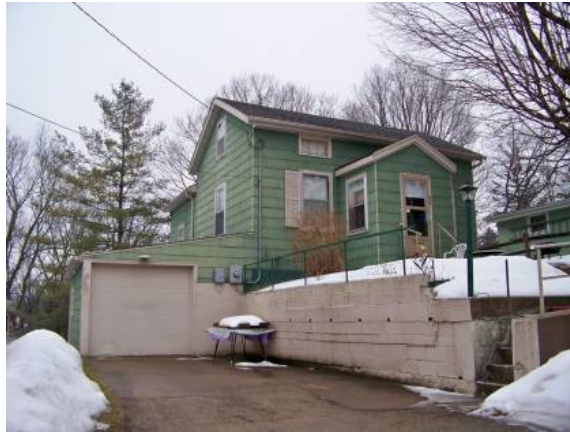
This is a 1.5-story domestic building built ca. 1900. The foundation is concrete block. Exterior walls are asbestos siding. The building has a side-gable roof clad in asphalt shingles. Windows are original or historic; contemporary wood; vinyl 1/1; 3-light double- or single-hung; awning. The porch is contemporary, Less than Full-Height Entry; Enclosed; Asbestos siding materials; Front-Gable roof. Entrance has been enclosed as a vestibule area. Garage addition.
