**KENTUCKY HISTORIC PROPERTIES
SURVEY FORM 2017-01**

commercial building

306-308 Main St, Shelbyville, Kentucky

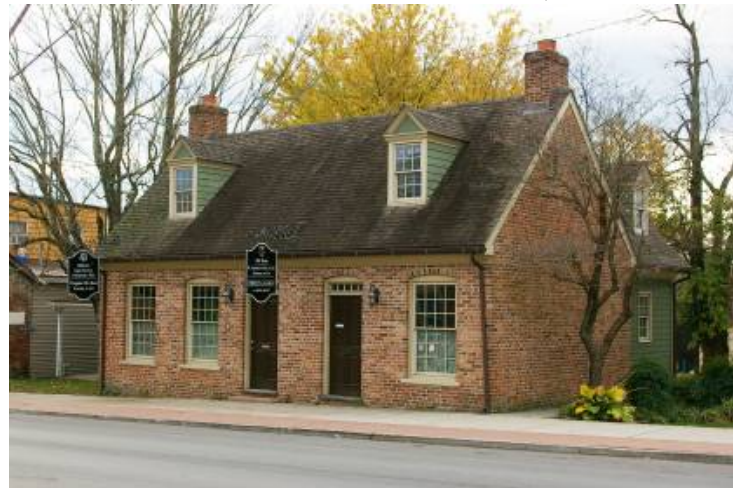
26. PHOTO: (Place Additional Photos below under 26 cont'd)

This is a 1.5-story, 4-bay commercial building in the Colonial Revival style built in the period 1910-1919. The structural system is masonry. The foundation is continuous brick. Exterior walls are original brick. The building has a medium side gable roof clad in replacement asphalt shingles with flush eaves and two gabled dormers. There is one offset left, straddle ridge, brick chimney and one offset right, straddle ridge, brick chimney. Windows are replacement wood, 12/12 double-hung sashes. There are two single-entry doorways with multi-light transom windows. There is a two-story, rear, frame addition. Residential structure added at rear. Residential structure added at rear. Renovated

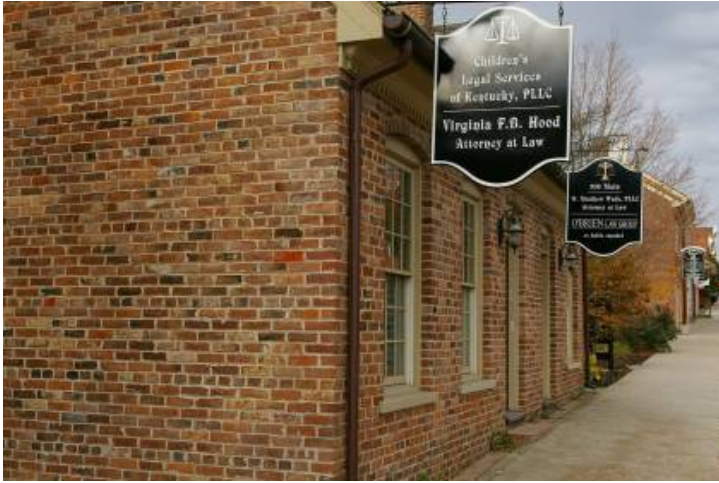
Caption: 306-308 Main detail

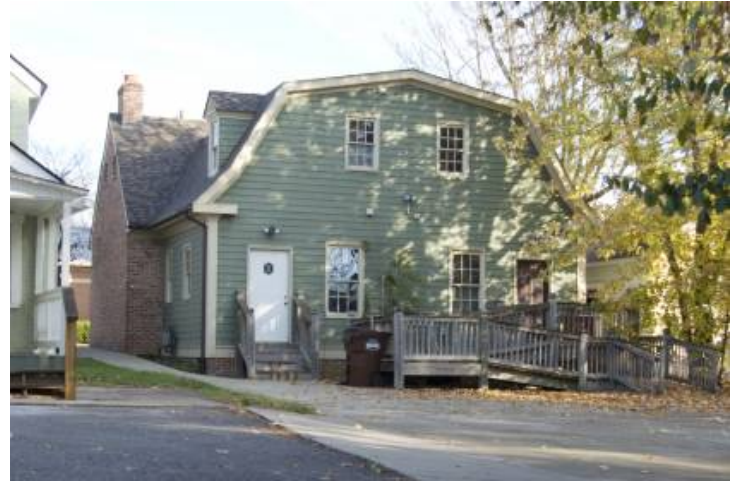
Caption: 306-308 Main rear view
