HISTORIC RESOURCE INVENTORY FORM

Resource Address: 613 N Main St Columbia Illinois 62236 USA
County: Monroe
Historic name: Sears Home
Present name:
Local place name:
Visible from public right of way:
Ownership:
Owner/Address:
Land unit size:
Site/Setting:

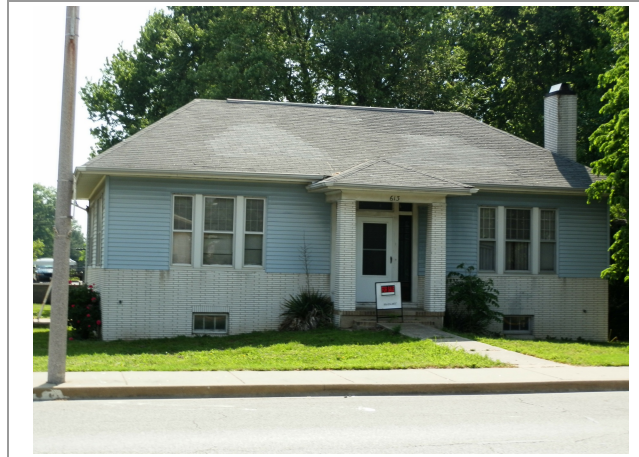
This is a 1-story single-family residence. The foundation is raised brick. Exterior walls are original brick and modern vinyl siding. The building has a medium hip roof clad in modern asphalt shingles with open cornice. There is one side right, exterior, brick chimney. Windows are modern vinyl, 6/1 double-hung sashes. It appears that all of the main floor windows have been replaced. There is a single-story, single-bay central open porch characterized by a hip roof clad in asphalt shingles with battered brick posts. Entrance with transom and sidelights. Covered in modern screen door. Potential Local Landmark
