KENTUCKY HISTORIC PROPERTIES
SURVEY FORM 2017-01

COUNTY: Shelby County
RESOURCE NUMBER: SHS 530
EVALUATION: H / NR District Contributing N / Eligible
Member of a Group
CONDITION: G / Good - in good state of repair

516 3rd St, Shelbyville, Kentucky. Block Number 26

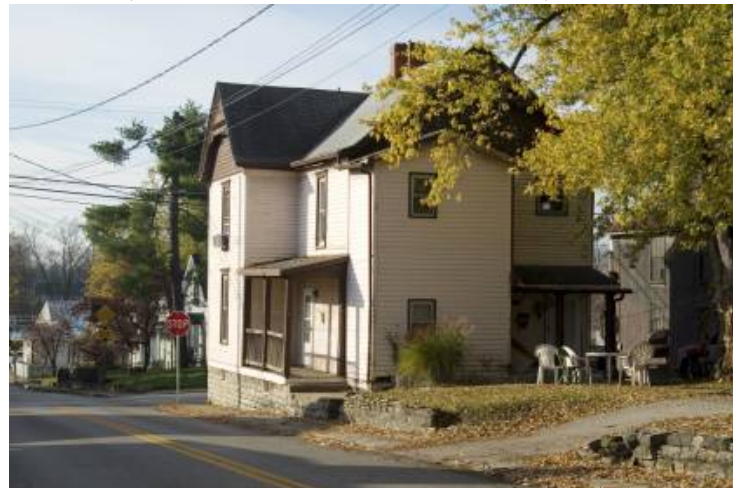
26. PHOTO: (Place Additional Photos below under 26 cont'd)

This is a 2-story, multiple-bay domestic building built in the period 1890-1899. The structural system is frame. The foundation is stone. Exterior walls are original weatherboard. The building has a cross gable roof clad in replacement asphalt shingles with box cornice. There is an internal brick chimney. Windows are original wood, 1/1 double-hung sashes. There is a side porch. There is a two-story, rear, frame addition. Rear Addition
