**KENTUCKY HISTORIC PROPERTIES
SURVEY FORM 2017-01**

COUNTY: Shelby County
RESOURCE NUMBER: SHS 566
EVALUATION: H / NR District Contributing N / Eligible
Member of a Group
CONDITION: G / Good - in good state of repair

domestic building

406 8th St, Shelbyville, Kentucky. Block Number 7

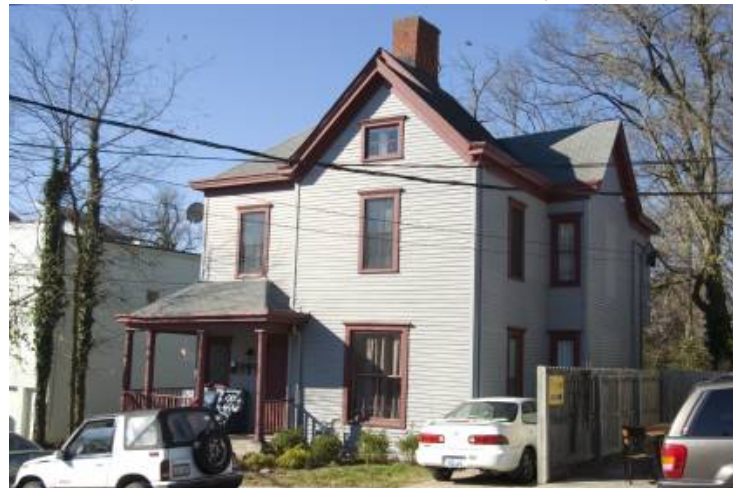
26. PHOTO: (Place Additional Photos below under 26 cont'd)

This is a 2-story, multiple-bay domestic building built in the period 1900-1909. The building is irregular in plan. The structural system is frame. The foundation is stone. Exterior walls are original weatherboard. The building has a multi-plane cross gable roof clad in replacement asphalt shingles with flush eaves. There is an internal brick chimney. Windows are original wood, 1/1 double-hung sashes. There is a single-story, single-bay porch characterized by a shed roof clad in asphalt shingles with round wood posts.

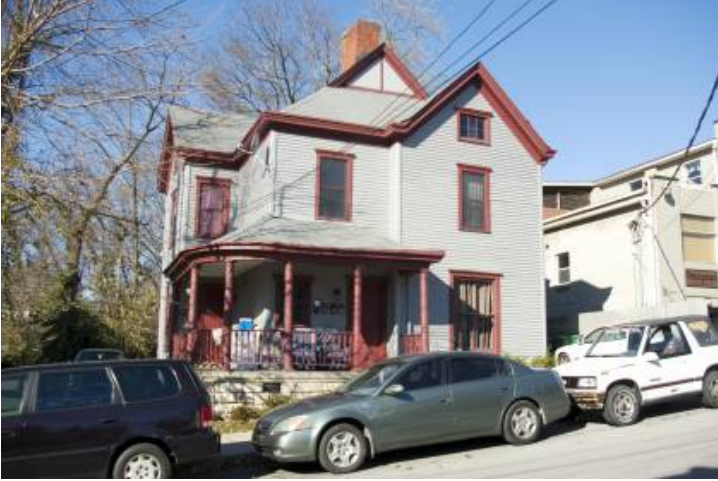
27. (continued) ADDITIONAL IMAGES:

Caption: (source: Jim Cleveland)
