**KENTUCKY HISTORIC PROPERTIES
SURVEY FORM 2017-01**

commercial building

324 Main St, Shelbyville, Kentucky

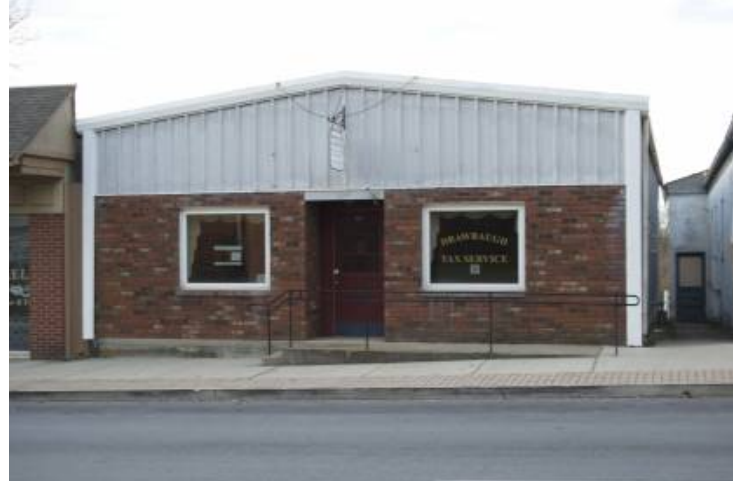
26. PHOTO: (Place Additional Photos below under 26 cont'd)

This is a 1-story, multiple-bay commercial building in the 20th Century Commercial style built in the period 1970-1979. The building is rectangular in plan. The structural system is frame. The foundation is poured concrete. Exterior walls are original brick veneer and original vertical aluminum panels. The building has a low front gable roof clad in modern corrugated metal with flush cornice. Windows are modern, 1-light fixed. There is a single-entry doorway flanked by two fixed window bays.

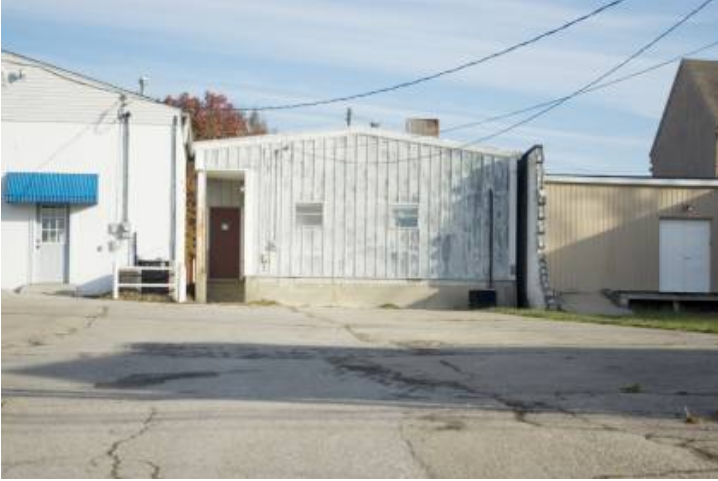
Caption: 324 Main rear view (Source: Jim Cleveland)
