KENTUCKY HISTORIC PROPERTIES
SURVEY FORM 2017-01

COUNTY: Shelby County
RESOURCE NUMBER: SHS 746
EVALUATION: N / Eligible Member of a Group
CONDITION: G / Good - in good state of repair

commercial building

721 Main St, Shelbyville, Kentucky

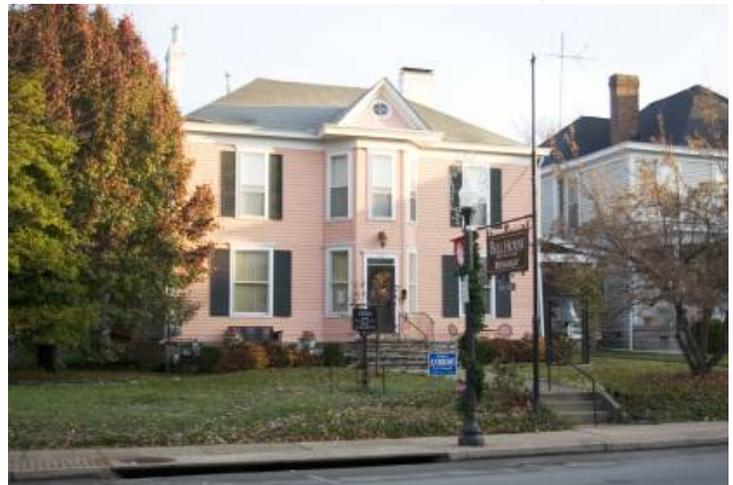
26. PHOTO: (Place Additional Photos below under 26 cont'd)

This is a 2-story, 3-bay commercial building in the Folk/Traditional style built in the period 1890-1899. The structural system is frame. The foundation is stone. Exterior walls are historic wood siding. The building has a hip with center gable roof clad in replacement asphalt shingles with flush eaves. There is one side left, exterior, brick chimney and one offset right, side slope, brick chimney. Windows are replacement vinyl, 1/1 double-hung sashes. The primary entry is situated in the center of a two-story, three-sided projecting bay with a gable peak. There is a two-story, rear, frame addition.
