**KENTUCKY HISTORIC PROPERTIES  
SURVEY FORM 2017-01**

COUNTY: Shelby County  
RESOURCE NUMBER: SHS 666  
EVALUATION: H / NR District Contributing  
CONDITION: E / Excellent - Fully utilized

1508 Main St, Shelbyville, Kentucky. 1

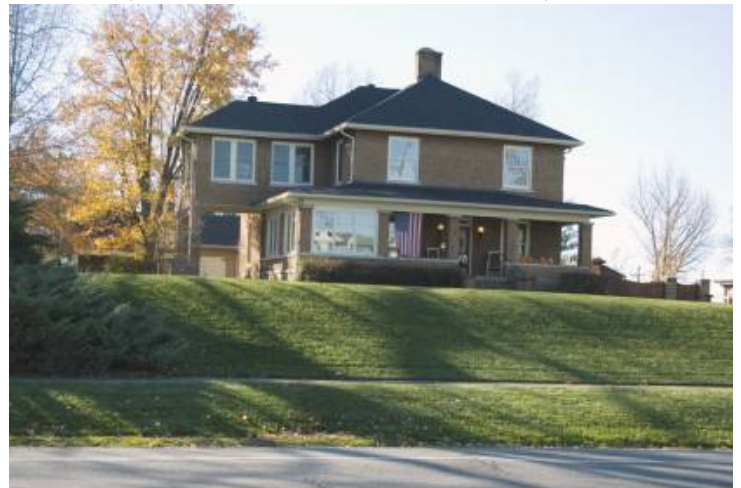
**26. PHOTO:** (Place Additional Photos below under 26 cont'd)

This is a 2-story domestic building built in the period 1920-1929. The structural system is frame. The foundation is stone. Exterior walls are original brick veneer. The building has a multi-plane/complex roof clad in replacement asphalt shingles. There is an internal brick chimney. Windows are historic wood, 1/1 double-hung sashes. There is a partially enclosed, wrap around porch element. Appears to have a substantial rear addition.
