HISTORIC RESOURCE INVENTORY FORM

Resource Address: 404 S Main St Galena Illinois 61036 USA
County: Jo Daviess
Historic name: Commercial building
Present name: La Vie En Rose
Local place name:
Visible from public right of way: Yes
Ownership:
Owner/Address:
Land unit size:
Site/Setting:

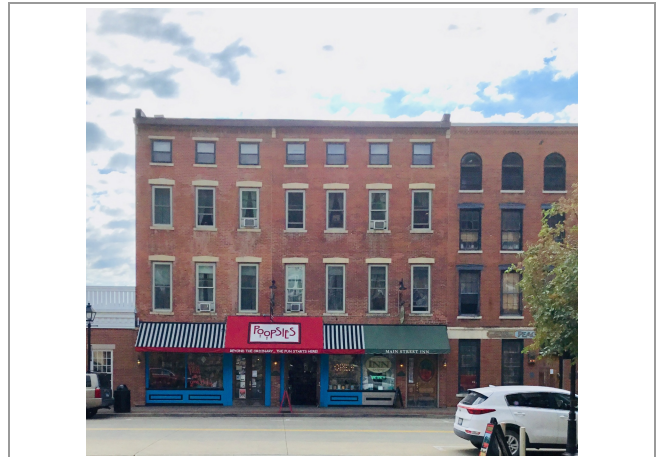
Photo taken September 2019

This is a 3.5-story commercial building in the Italianate style built ca. 1856. The foundation is not visible. Exterior walls are brick. The building has a flat roof. Windows are original or historic wood 1/1 fixed; double-or single hung. Doors are contemporary glass glazed; recessed entry with transom; sidelights. Dentils; Cornice Brackets. Pedimented store window lintels and stone sills. Original cast iron and wood storefront. Iron lintel above storefront.
