HISTORIC RESOURCE INVENTORY FORM

Resource Address: 906 Park Ave Galena Illinois 61036 USA
County: Jo Daviess
Historic name: Beebe House
Present name: House
Local place name:
Visible from public right of way: Yes
Ownership:
Owner/Address:
Land unit size:
Site/Setting:

Survey and Recorder		
Project: Galena National Register Historic District	Sequence/Key no.:	Survey Date:
Prepared By:	Report Title/Name:	Previous Surveys:
Inventoried: 12/10/2013 8:57:09 pm Last updated: 12/10/2013 8:57:09 pm by /	Level of Survey: <input type="checkbox"/> Reconnaissance <input type="checkbox"/> Intensive	Additional Research Recommended? <input type="checkbox"/> Yes <input type="checkbox"/> No

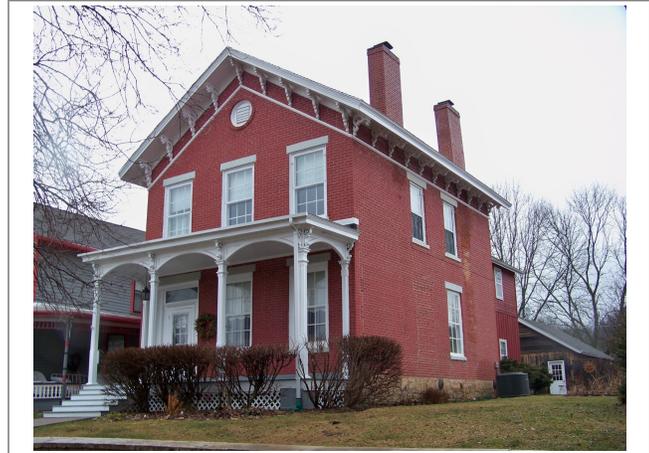
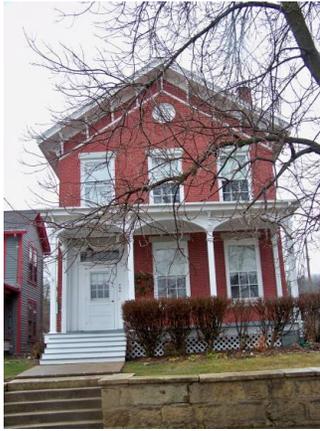
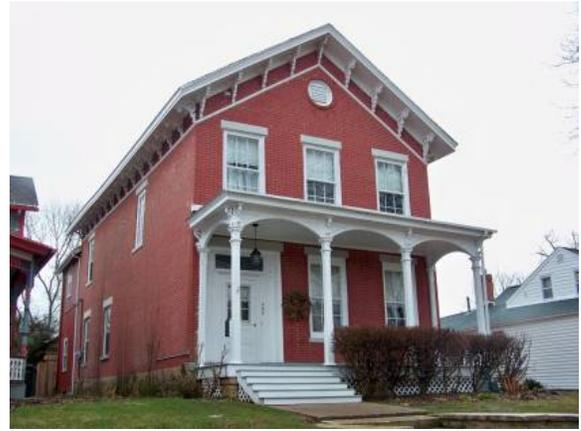
This is a 2-story domestic building in the Italianate style built ca. 1870. The foundation is limestone. Exterior walls are brick. The building has a front-gable roof clad in asphalt shingles. Windows are original wood 6/6 double- or single-hung. The porch is original or historic, Full-width, one-story; Wood materials; Deck roof; Square supports. Doors are original or historic wood glazed with transom, molding. Cornice molding, cornice brackets.
