HISTORIC RESOURCE INVENTORY FORM

Resource no. NAHRGIS 247297

Resource Address: 717 W 1st Ave Albany Georgia 31702 United States (Palmyra Heights)
County: Dougherty
Historic name:
Present name:
Local place name:
Visible from public right of way: Yes
Ownership: Private
Owner/Address:
Land unit size:
Site/Setting:

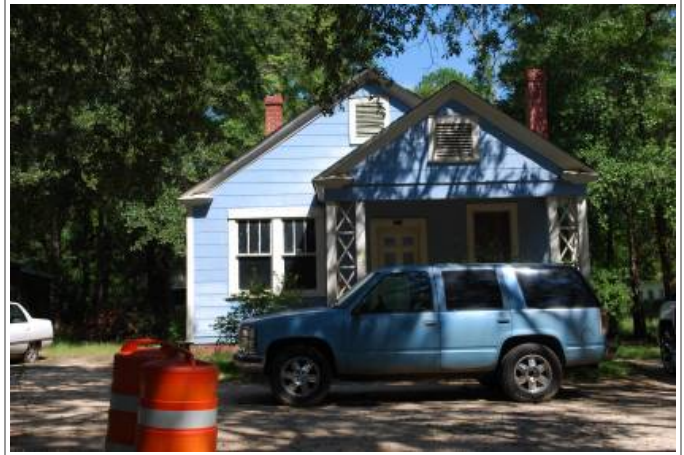
This is a 1-story house in the No Academic Style built in 1935. The building is rectangular in plan. The structural system is frame. Exterior walls are asbestos. The building has a medium front gable roof clad in asphalt shingles. Windows are original wood, vertical 3/1 double-hung sashes.
