# HISTORIC RESOURCE INVENTORY FORM

Resource Address: <b>211 Clinton Ave Oak Park Illinois 60302 USA</b>
County: Cook
Historic name:
Present name:
Local place name:
Visible from public right of way: Yes
Ownership:
Owner/Address:
Land unit size:
Site/Setting:

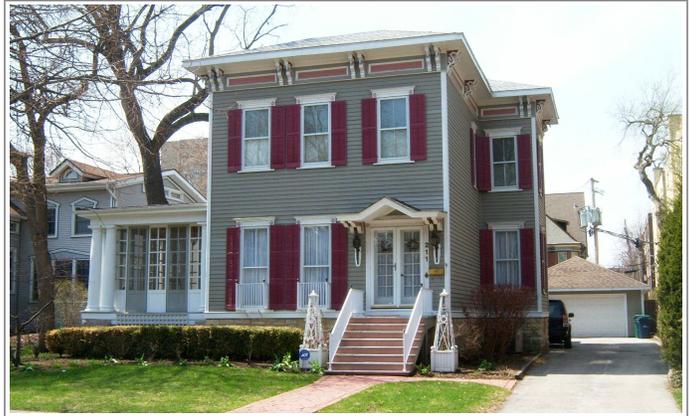
Depicted on an 1873 map of Oak Park, this Italianate residence originally was a modest-sized house with a rooftop cupola. The enclosed porch and rear section of the house are additions. The Lemont limestone foundation was carefully matched in the remodelling process. The low hipped roof, bracketed eaves, and tall, narrow windows are typical Italianate features. When built, the house probably had a front and back parlor, dining room, and lean-to kitchen on the first floor, with four bedrooms on the second floor. Most of the interior woodwork is pine with the exception of a mahogany bannister on the front stairs (Ridgeland Revealed p31).

This is a 2-story single-family residence in the Italianate style built ca. 1873. The structural system is frame. The foundation is stone. Exterior walls are original wood clapboard. Heavy decorative wood window surrounds. The building has a low hip roof clad in replacement asphalt shingles and paired brackets. There is one center, straddle ridge, brick chimney. Windows are original wood, 2/2 double-hung sashes. Also 1-over-1 double-hung windows. There is a single-bay platform/stoop characterized by a gabled canopy with bracket supports roof clad in asphalt shingles. Double entry doors. Paired brackets in the cornice; two-story box bays on north and south; one-story enclosed side porch on south with paired columns.

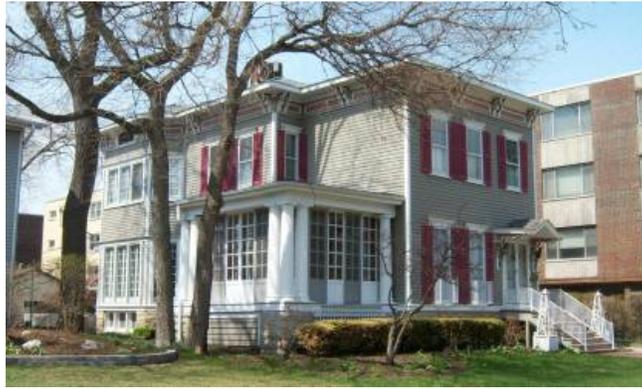
**Description/Remarks**
