HISTORIC RESOURCE INVENTORY FORM

Resource Address: 252 Lake St Oak Park Illinois 60302 USA
County: Cook
Historic name:
Present name:
Local place name:
Visible from public right of way: Yes
Ownership:
Owner/Address:
Land unit size:
Site/Setting:

Survey and Recorder		
Project: Village of Oak Park	Sequence/Key no.:	Survey Date: December 4, 2014
Prepared By: Douglas Kaarre, AICP Village of Oak Park	Report Title/Name: Survey and Planning	Previous Surveys: Second District Survey 1978
Inventoried: 12/04/2014 11:07:45 pm Last updated: 03/20/2020 11:17:32 am by /	Level of Survey: <input type="checkbox"/> Reconnaissance <input checked="" type="checkbox"/> Intensive	Additional Research Recommended? <input type="checkbox"/> Yes <input checked="" type="checkbox"/> No

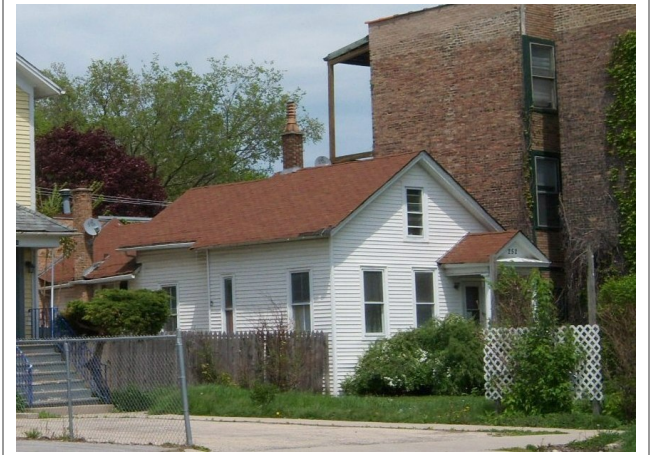
This is a 1.5-story single-family residence in the Folk/Traditional style built ca. 1875. The structural system is frame. Exterior walls are modern vinyl siding and original brick. Rear brick addition. The building has a low front gable roof clad in replacement asphalt shingles. There is one center, straddle ridge, brick chimney. Windows are replacement vinyl, 1/1 double-hung sashes. There is a single-story, single-bay open porch characterized by a gabled roof clad in asphalt shingles with round wood posts. There is a single-story, rear, brick addition. Incompatible.
