**KENTUCKY HISTORIC PROPERTIES
SURVEY FORM 2017-01**

COUNTY: Shelby County
RESOURCE NUMBER: SHS 862
EVALUATION: _____
CONDITION: G / Good - in good state of repair

707 Washington St, Shelbyville, Kentucky

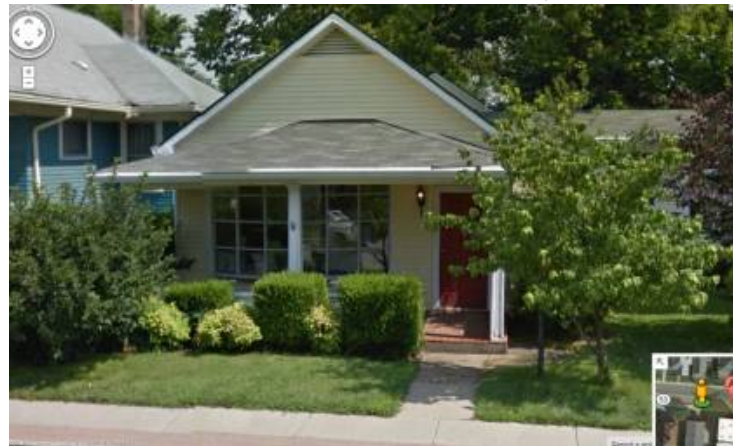
26. PHOTO: (Place Additional Photos below under 26 cont'd)

This is a 1.5-story, 2-bay domestic building built in the period 1950-1959. The building is irregular in plan. The structural system is frame. The foundation is undetermined. Exterior walls are replacement vinyl siding. The building has a high front gable roof clad in modern asphalt shingles with box cornice. There is a wooden, 20-light curved bay window at the front. The side windows are not visible. There is a single-story, full-span open porch characterized by a hip roof clad in asphalt shingles with battered wood posts.
