**KENTUCKY HISTORIC PROPERTIES
SURVEY FORM 2017-01**

COUNTY: Shelby County
RESOURCE NUMBER: SHS 882
EVALUATION: N / Eligible Member of a Group
CONDITION: G / Good - in good state of repair

commercial building

702 Washington St, Shelbyville, Kentucky

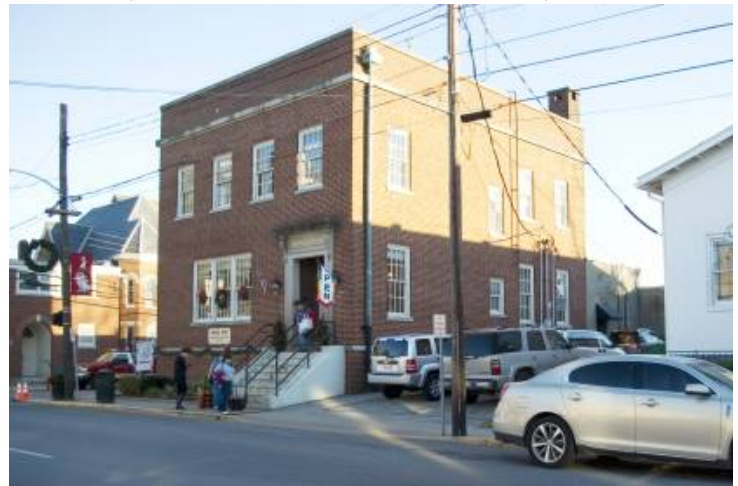
26. PHOTO: (Place Additional Photos below under 26 cont'd)

This is a 2-story, 2-bay commercial building in the Early 20th century commercial style built in the period 1910-1919. The building is rectangular in plan. The structural system is masonry. The foundation is continuous brick. Exterior walls are original brick. The building has a flat roof clad in replacement rubberized/asphalt composite with flush cornice and stone caps. There is one offset right, brick chimney. Windows are historic wood, 8/8 double-hung sashes.
