KENTUCKY HISTORIC PROPERTIES
SURVEY FORM 2017-01

COUNTY: Shelby County
RESOURCE NUMBER: SHS 606
EVALUATION: H / NR District Contributing
CONDITION: F / Fair - undermaintained

domestic building

822 Bland Ave, Shelbyville, Kentucky. Block Number 5

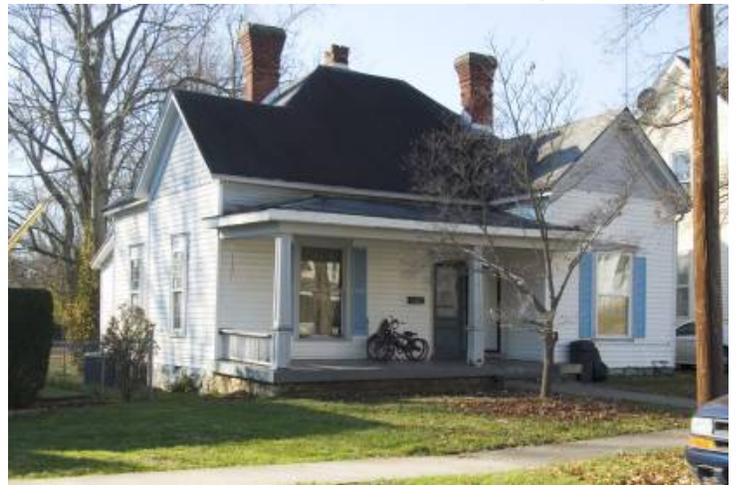
26. PHOTO: (Place Additional Photos below under 26 cont'd)

This is a 1-story, multiple-bay domestic building in the Queen Anne style built in the period 1910-1919. The structural system is frame. The foundation is stone. Exterior walls are replacement vinyl siding. The building has a center gable roof clad in replacement asphalt shingles. There are three interior brick chimneys. Windows are original wood, 1/1 double-hung sashes. There is a front porch element.
