KENTUCKY HISTORIC PROPERTIES
SURVEY FORM 2017-01

COUNTY: Shelby County
RESOURCE NUMBER: SHS 707
EVALUATION: N / Eligible Member of a Group
CONDITION: F / Fair - undermaintained

domestic building

1316-1318 Main St, Shelbyville, Kentucky. FAIRVIEW SUB LOT 5

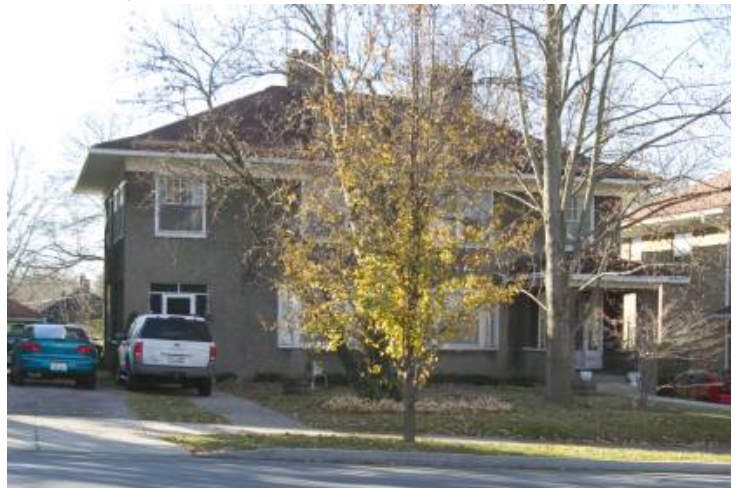
26. PHOTO: (Place Additional Photos below under 26 cont'd)

This is a 2-story, 4-bay domestic building in the Craftsman style built in the period 1920-1929. The building is square in plan. The structural system is frame. The foundation is poured concrete. Exterior walls are replacement stucco. The building has a bellcast hip roof clad in replacement asphalt shingles with box cornice and dentil moulding. There are two straddle ridge, stuccoed chimneys. Windows are original wood, 12/1 double-hung sashes. The windows on the ground floor facade are flanked by divided sidelights. The upper story features twin 8 over 1 double hungs. There is a single-story, single-bay open porch characterized by a hip roof clad in asphalt shingles with square stuccoed posts. The eastern porch has been removed. Both eastern and... western entry doors appear to be modern replacements.
